CRANE'S CHRONICLES

SAFETY IS NEWSWORTHY

First Edition April 2004

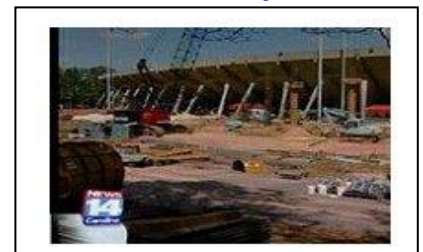
Worker killed at Carter-Finley

A construction accident at N.C. State's football stadium killed

one man and injured two others on Monday. The men

were working on the new press box for Carter-Finley Stadium.

"They were actually working on raising the columns with rebar to pour for concrete on our new press box here at the stadium," NCSU Police Sgt. Jon Barnwell said.

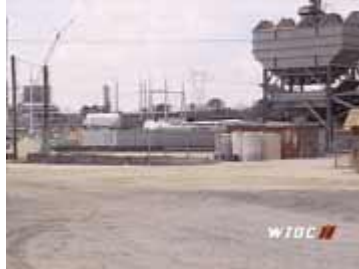
Plant McIntosh

Second Construction Worker Dies

Tragedy has struck twice at an Effingham

County construction site. This morning, Johnny Boyette of Bonafey, Florida, fell to his death on the job. That's the second time in less than two weeks that a construction worker has died at Plant McIntosh. WG Yates and Sons Construction has suspended all work at the site until it completes an investigation.

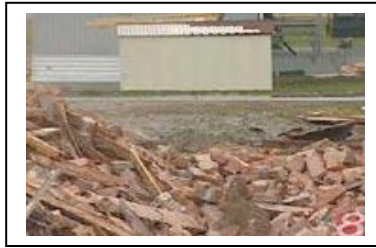
Barbershop Accidentally Demolished

A barbershop fell victim to a wrecking ball by accident Tuesday. Neighbors say the small-town barbershop in Michigantown, close to Frankfort, was not part of the demolition plans when the wrecking ball was released.

Worker's pursuing a demolition project knocked down an older brick building Tuesday afternoon, then clobbered Ralph Webb's adjoining barbershop by accident.
